# Wascana Riparian Health Assessment 2012-14. Part 3- Downstream of Regina

Wascana Upper Qu'Appelle Watersheds Association Taking  
Responsibility (WUQWATR)

# Wascana Riparian Health Assessment Project: 2014 Interim Report

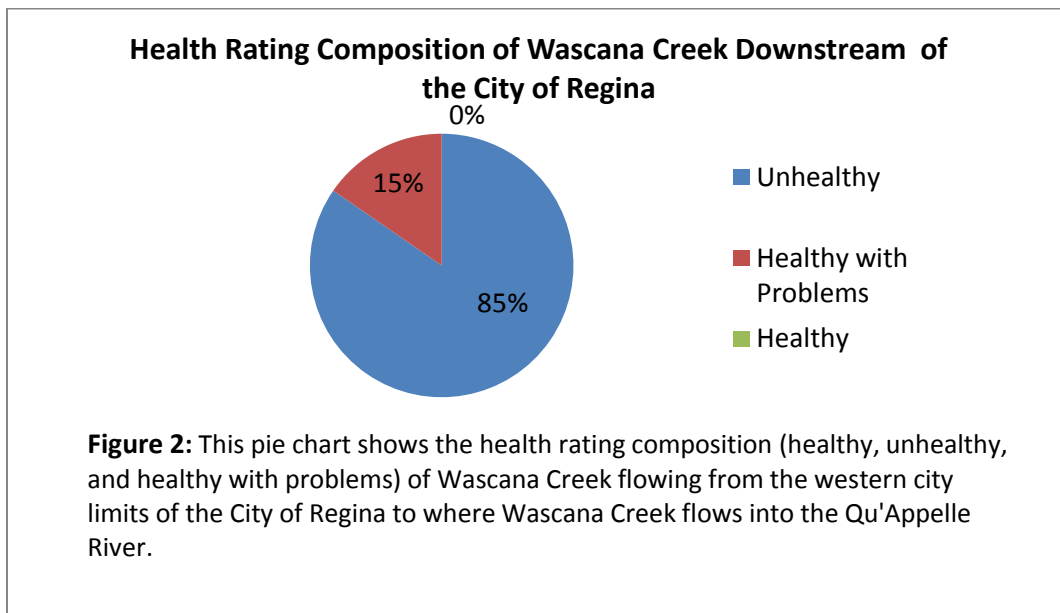
There were no “healthy” sites along Wascana Creek downstream of the City of Regina. Only 4 sites were scored as “healthy with problems” (15%) and 22 sites were rated as “unhealthy” (85%). The average health score of the downstream portion of Wascana Creek was 48.1% which rated as “unhealthy”.

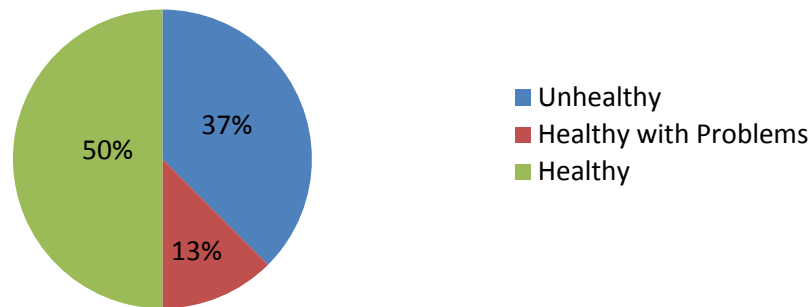
There were 8 sites assessed on Cottonwood Creek, ranging from SK-730 grid in the south to where Cottonwood Creek joins Wascana Creek. Of these 8 sites, 4 were “healthy” (50%), 3 were “unhealthy” (37%) and only one fell in the category of “healthy with problems” (13%).

**Figure 3:** This pie chart shows the health rating composition (healthy, healthy with problems, and unhealthy) of Cottonwood Creek from grid SK-730 to where it joins Wascana Creek.

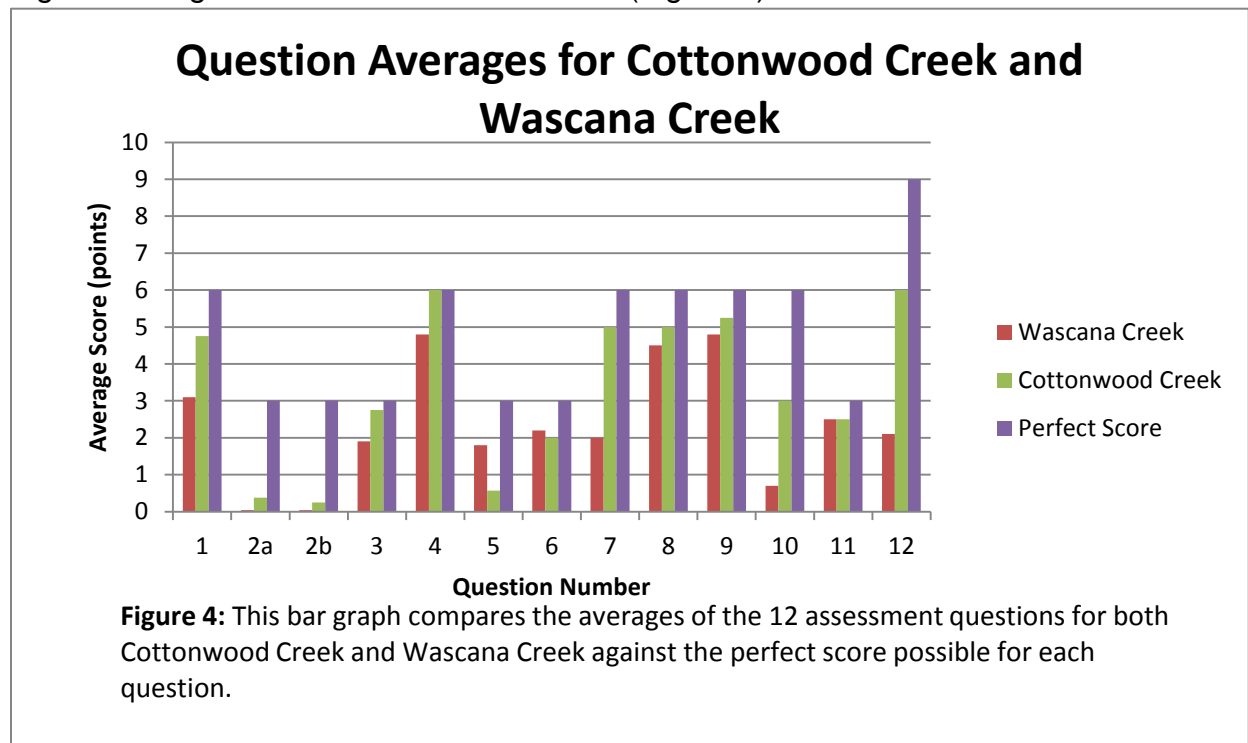
The relative health scores of both Wascana and Cottonwood Creeks decline as one moves downstream. When compared to a perfect score, Cottonwood Creek has a much higher average score than Wascana Creek (Figure 4).

The average health for Wascana Creek sites scored an average health rating of 48.0% or “unhealthy”. These scores were not chiefly attributable to local management or environmental factors, but were consistent with problems arising from increased water flows and management activities in the larger watershed.

Cottonwood Creek has an overall average score of 69.5% or “healthy with problems”. This indicates that although there are some factors impairing overall health, the Cottonwood Creek system has considerably higher levels of resilience and function than its receiving water body.

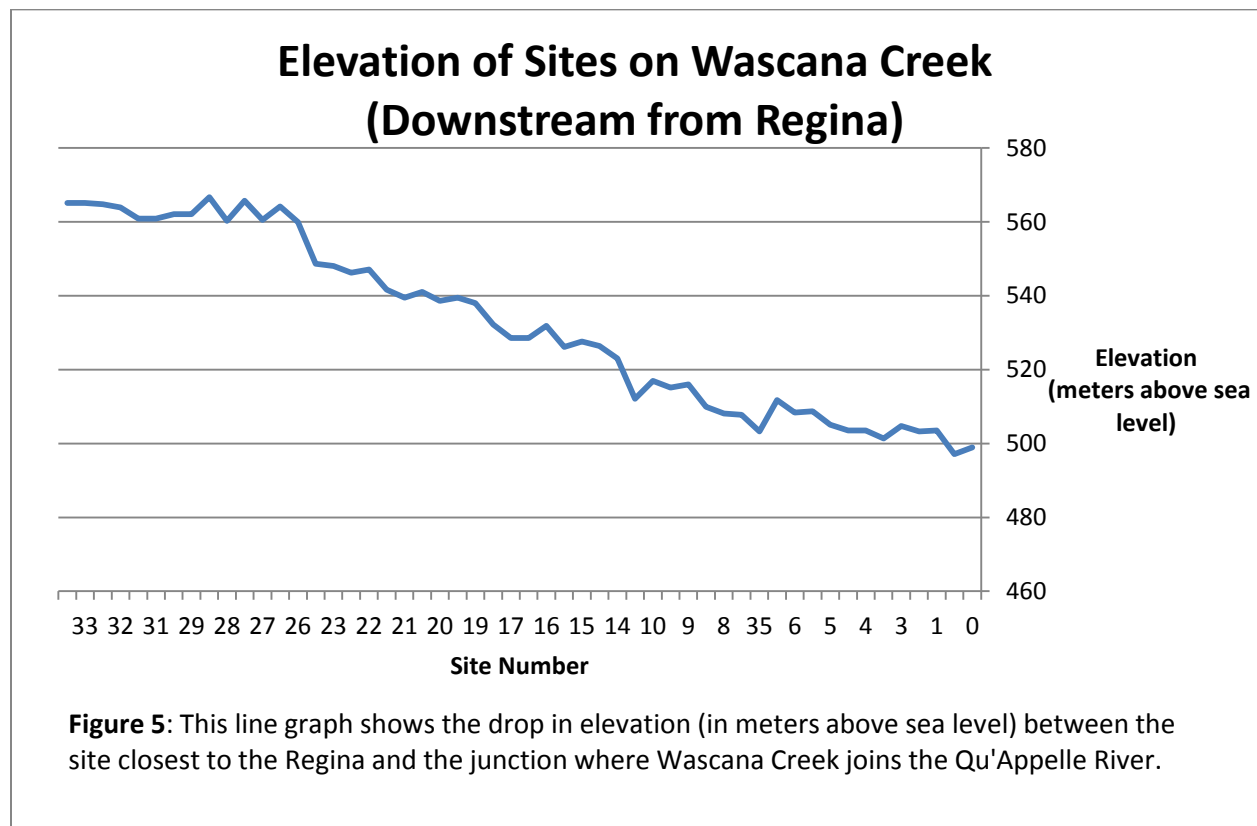
The drop in elevation as the creek gets farther from the city speeds up the water (Figure 5). The increase in the speed as well as the increase in volume of water increases active lateral cutting and riparian areas are washed away.

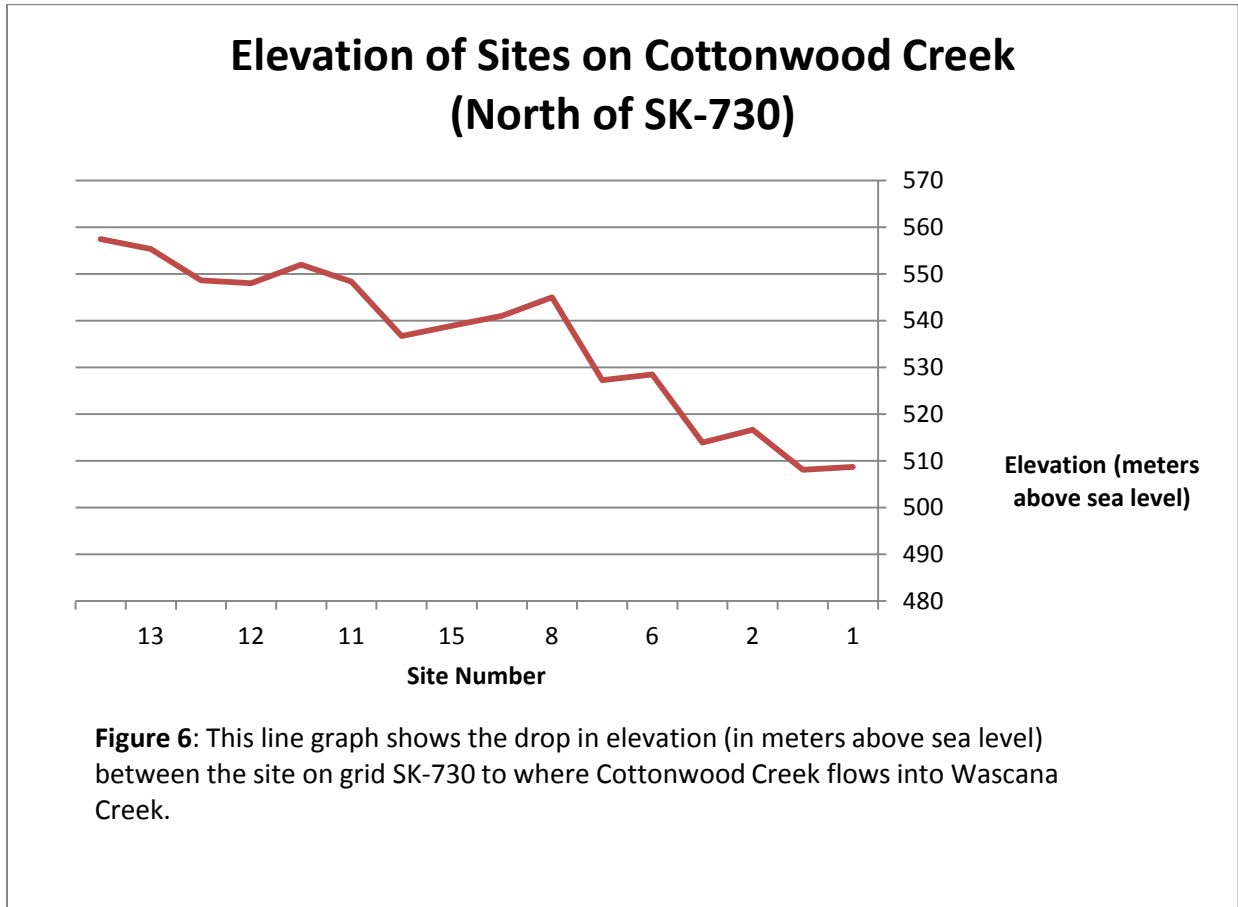
A similar pattern appears on the Cottonwood. As seen in Figure 6, the elevation falls as the Cottonwood flows toward Wascana Creek. Health scores decline along with the declining elevation, as reflected by the health score of the 8 sites selected along the creek (Figure 7). However, Cottonwood Creek has the advantage of having a less erodible soil along the banks.
