# Last Mountain Lake Shoreline Assessment Summary Report

Submitted by Watersheds Canada and the Canadian Wildlife Federation.

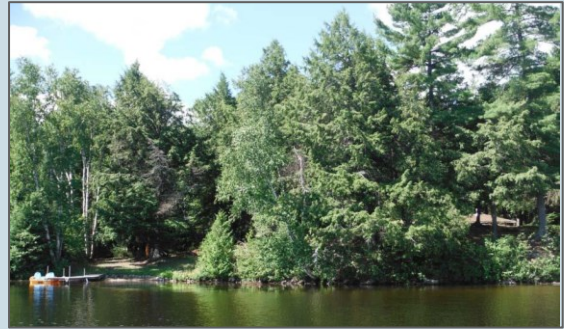
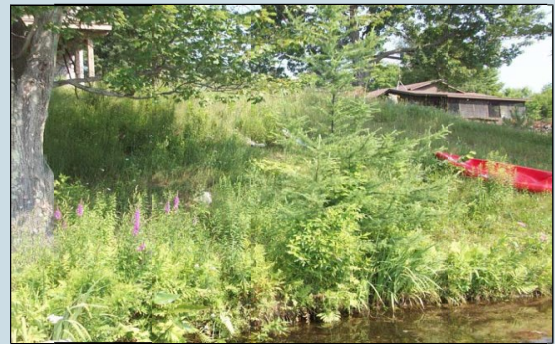
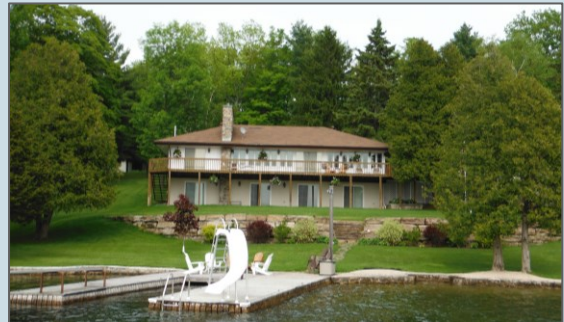
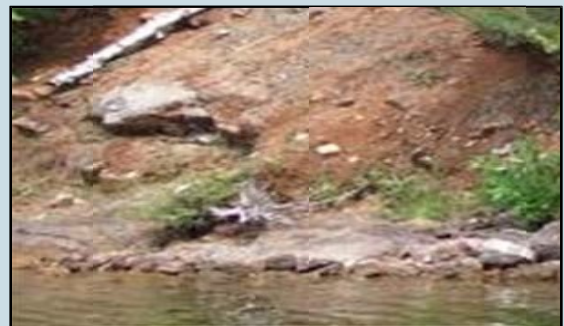
## Photograph Example\*

**Natural** – A healthy buffer of vegetation and/or a natural shoreline of sand or exposed rock that is undisturbed and undeveloped.

**Regenerative** – Natural vegetation has been removed in the past, but is in the process of growing back towards a natural state.

**Ornamental** – All natural vegetation has been removed and replaced with mowed lawn and other non-native vegetation; structures such as docks, decks, boathouses and boat ramps are predominantly present at the shore.

**Degraded** – Natural vegetation has been lost; soil erosion, undercutting of the bank and/or exposed roots of shrubs and trees are significant.

**\*Note:** These photographs are examples of shoreline classes, not representing any specific shoreline property on Last Mountain Lake. There can be a range of variation in the classifications depending on the type of shoreline.

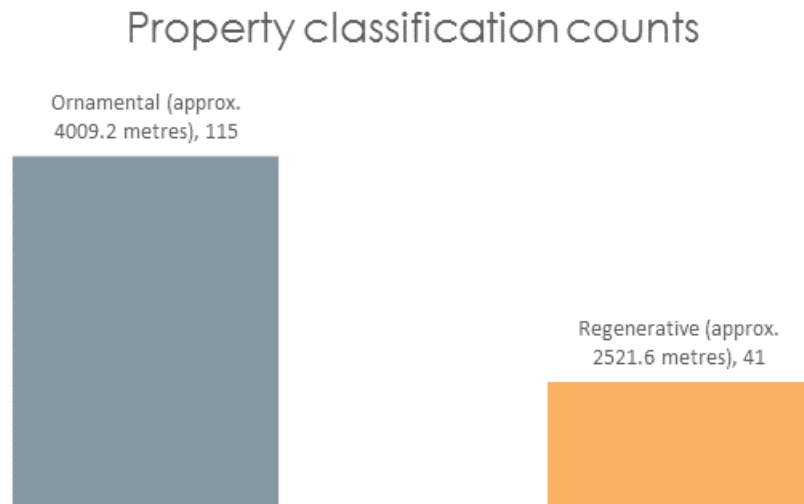
Figure 1 Property Classifications

Figure 1 shows the counts of property classifications on the lake. For example, a property that was 60% Natural, 20% Ornamental and 20% Regenerative would be classified as Natural. Alternatively, a property that was classified as 40% Ornamental, 30% Regenerative and 30% Natural would be classified as Ornamental.

On Last Mountain Lake, 0 shoreline properties were classified as majority natural, 115 majority ornamental and 41 were considered majority regenerative. It is recommended that shoreline property owners engage in naturalization projects to further decrease the ornamental percentage and increase the regenerative and natural percentages.

This presents an opportunity for residents of Last Mountain Lake to increase the overall quality of the lake by maintaining, protecting and enhancing natural shorelines. To restore shorelines to a more natural state, property owners are encouraged to take action. Regenerative properties should also be encouraged to maintain their properties in a natural state by allowing their vegetation on their property to continue to regenerate and grow naturally.

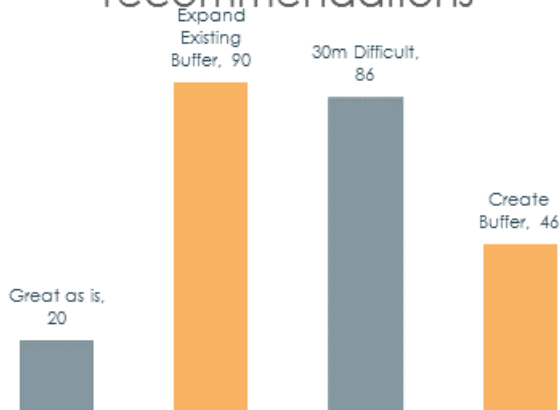
Figure 2 Buffer Recommendations

The survey of Last Mountain Lake characterized the types of restoration opportunities that exist around the lake on individual properties. Figure 2 summarizes the number of properties that were assigned a buffer recommendation during the survey. Each shoreline property can receive more than one recommendation.

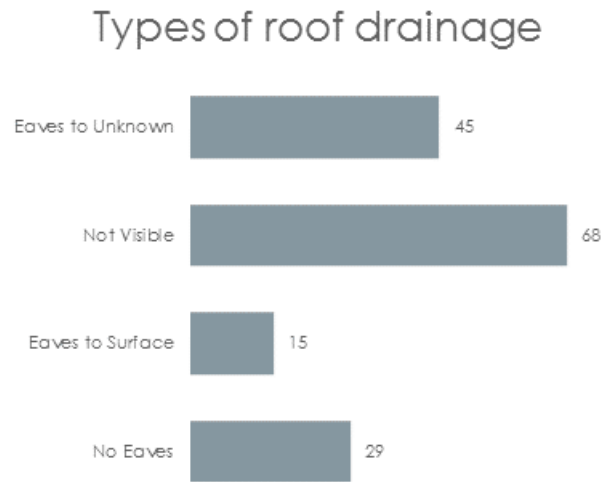
Figure 6 Roof Drainage types around lake

Naturalizing shorelines on properties with near-shore building setbacks would help reduce runoff from entering into Last Mountain Lake, which could help reduce potential problems such as algae blooms and loss of oxygen in the water. Property owners can also manage this problem by ensuring they have eave troughs with downspouts directed at natural or stone catch basins or rain barrels, as well as ensuring they have a properly functioning septic to process wastewater before it enters the lake. It is also important to use phosphate free products. Figure 6 shows the types of roof drainage that were recorded from the shoreline assessments.

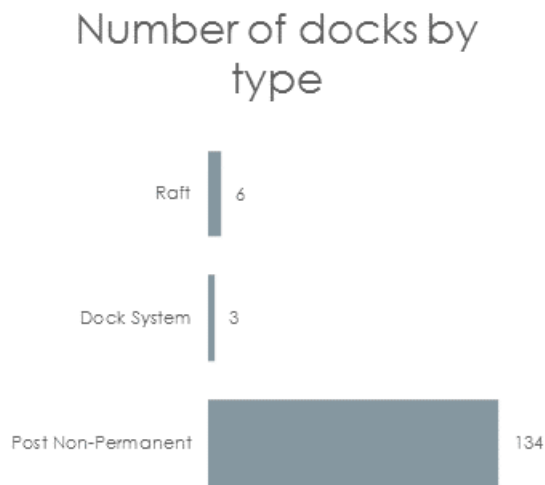
Figure 7 Docks On Lake

Shoreline development is defined as the presence of man-made structures in the water or along the shoreline within three metres of the shore. Development along a shoreline can be done sustainably and in an environmentally sensitive fashion, providing structures are well maintained and kept to a minimal footprint. Figure 7 and 8 illustrate the common structures present on Last Mountain Lake.

Small floating or non-permanent post docks are the most environmentally friendly choice, they allow natural water flow, have limited contact with the lake bottom, and reduce the overall potential for disturbance to aquatic life.

In the future, if shoreline property owners need to replace their old or failing permanent post, solid, or crib docks, they could consider choosing non-permanent post or floating docks. By selecting these types of docks,

people can reduce the potential impacts to fish and other aquatic species, which can help protect the overall health of the lake environment.

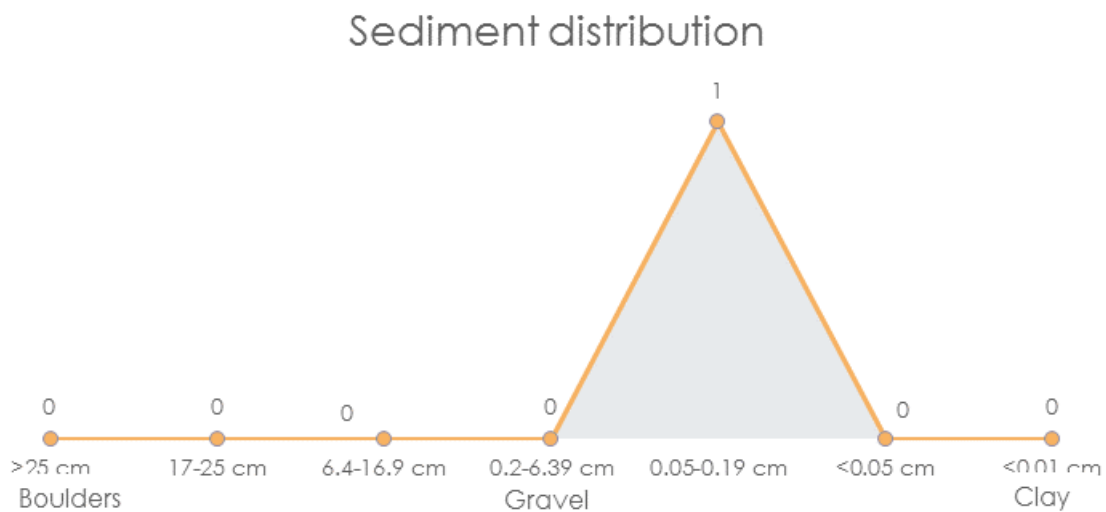
Figure 10 Sediment Distribution

On Last Mountain Lake, the type of sediment present on the lake bottom was observed. The benthic zone which is located on the lake bottom is classified as the ecological region at the lowest level of a body of water. It starts at the shoreline and continues down until it reaches the floor, encompassing the sediment surface and subsurface layers. Although this zone may appear barren, it plays a vital role in the health of aquatic ecosystems. Tiny, microscopic organisms which cycle nutrients live in this zone and act as a source of food for bottom feeding animals.

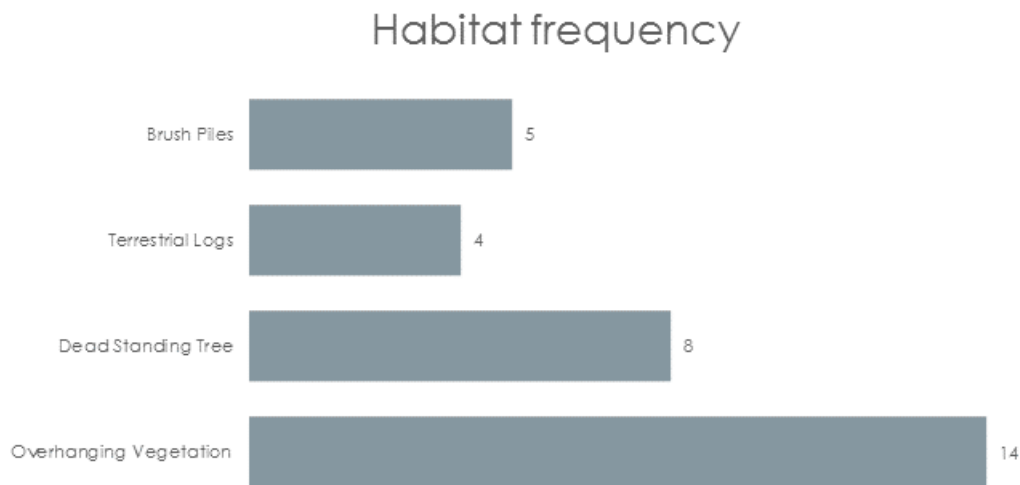
Figure 11 Habitat Present

The most common type of nearshore habitat on Last Mountain Lake was identified as overhanging vegetation, followed by dead standing trees. Wildlife provides us with many enjoyable and beneficial activities from bird watching and wildlife photography to pest control, seed dispersal, nutrient cycling and pollination, just to name a few. It is important for there to be a rich and diverse range of habitats along the lakeshore in order to ensure a healthy lake environment. Figure 11 summarizes the nearshore habitat.

It is important to leave large trees that are dead and dying in place, if it is safe to do so. They provide important habitat for a number of different wildlife species. Many species of birds and mammals depend on cavity trees for nesting, rearing young, roosting, feeding, storing food, escaping predators and hibernating. Fallen logs on land provide habitat for small mammals such as moles, woodpeckers, toads and insects. As the log decomposes, reptiles and amphibians lay their eggs in the moist wood. A decaying log is also great habitat for beetles and ants that burrow under the bark and lay eggs. In the water, logs provide important fish habitat by providing refuge for small fish and spaces for ambush predators such as pike to conceal themselves. By leaving dead and decaying brush and logs in place, you are helping contribute to a healthy and vibrant species community.
