# Wascana Riparian Health Assessment 2012-14. Part 3- Downstream of Regina

Wascana Upper Qu'Appelle Watersheds Association Taking  
Responsibility (WUQWATR)

# Wascana Riparian Health Assessment Project: 2014 Interim Report

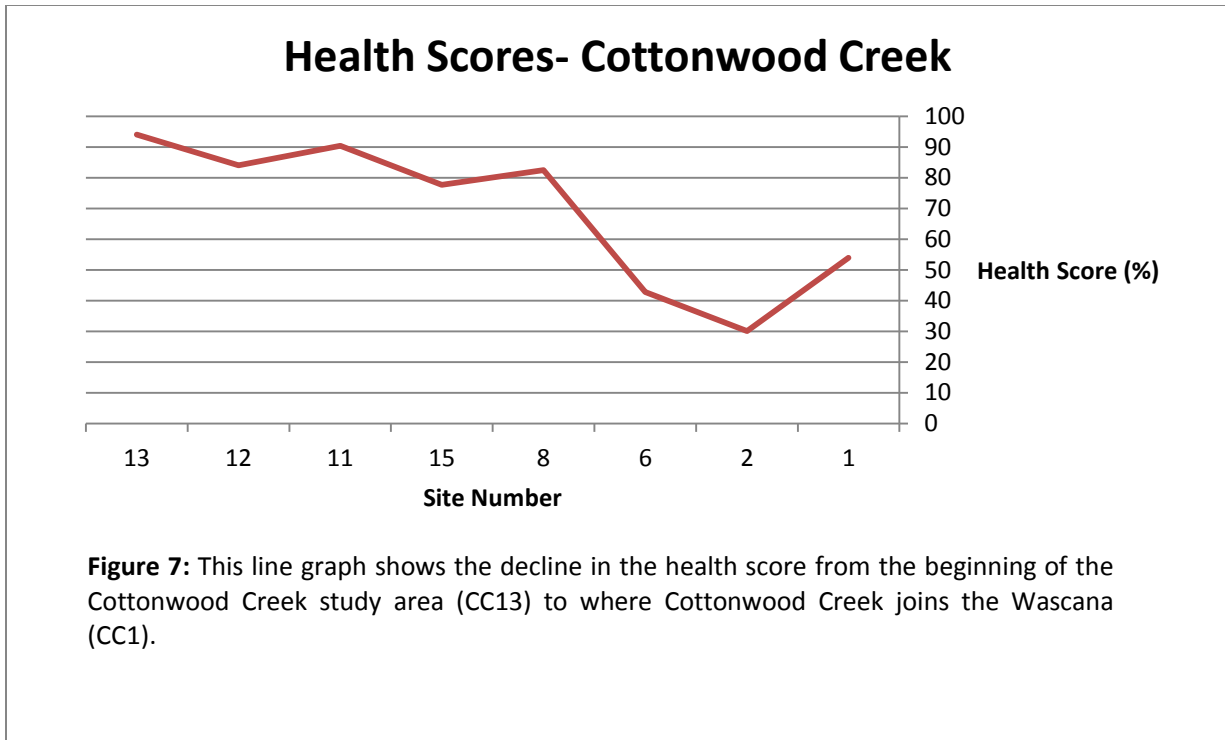
A similar pattern appears on the Cottonwood. As seen in Figure 6, the elevation falls as the Cottonwood flows toward Wascana Creek. Health scores decline along with the declining elevation, as reflected by the health score of the 8 sites selected along the creek (Figure 7). However, Cottonwood Creek has the advantage of having a less erodible soil along the banks.

Overall, the health scores of Wascana Creek declines as it flows from the western city limits to the junction of Wascana Creek and the Qu’Appelle River. This decline in riparian health is a result of an increase in lateral active cutting and incisement, both of which are results of the increased flow, constant flow, and the fast-flowing water.
